TECHNICAL REPORT CERC-85-8

BREAKWATER REHABILITATION STUDY, CRESCENT CITY HARBOR, CALIFORNIA

Coastal Model Investigation

Coastal Engineering Research Center

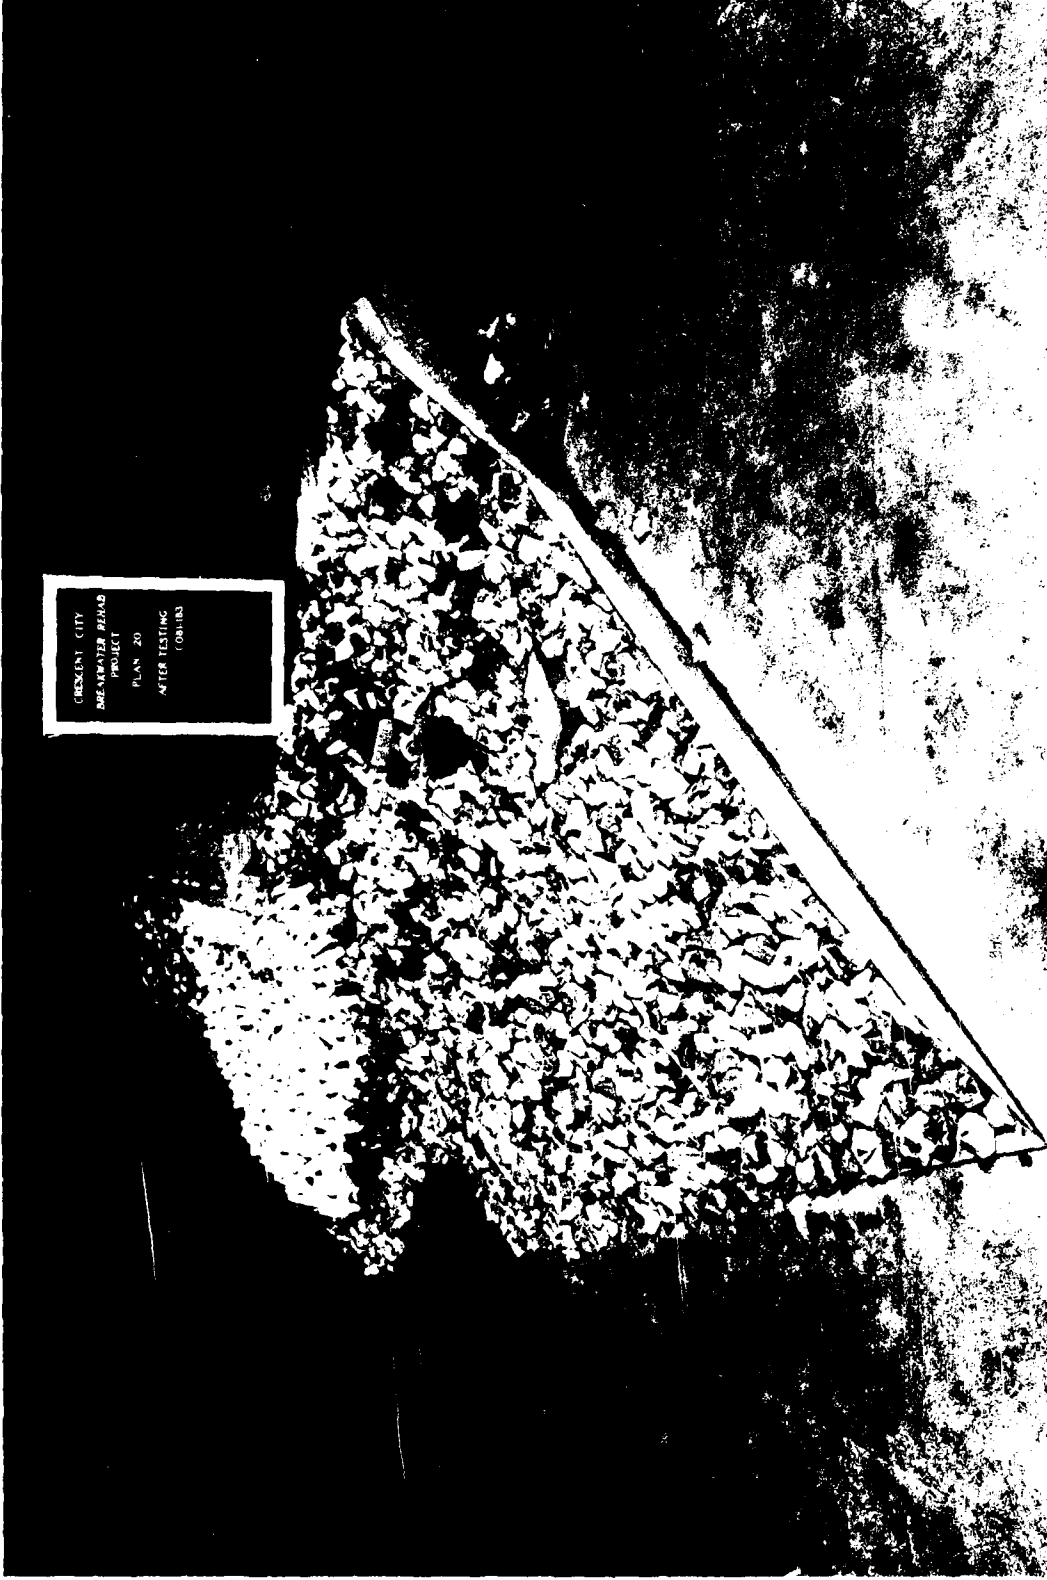
Photo 159. Seaward end view of Plan 20 after completion of abbreviated hydrograph

50. Plan 20 (Plate 22 and Photos 154-156) had about the same area of coverage as Plan 18; however, 74 rehabilitation dolosse were removed and replaced with 82 37-ton tetrapods (37-ton tetrapods were used since this was the model size tetrapod available nearest to the 42-ton dolos size). The tetrapods were placed in one layer. It was thought that the tetrapods might be a more appropriate shape for interfacing the existing stone. A total of 334 42-ton dolosse were used. The tetrapods suffered extensive damage. There was minimum movement of the dolosse during the abbreviated hydrograph, but since they had lost the protection afforded by the tetrapods it is likely damage would have progressed to this area for a longer duration storm. Photos 157-159 show the structure after testing.

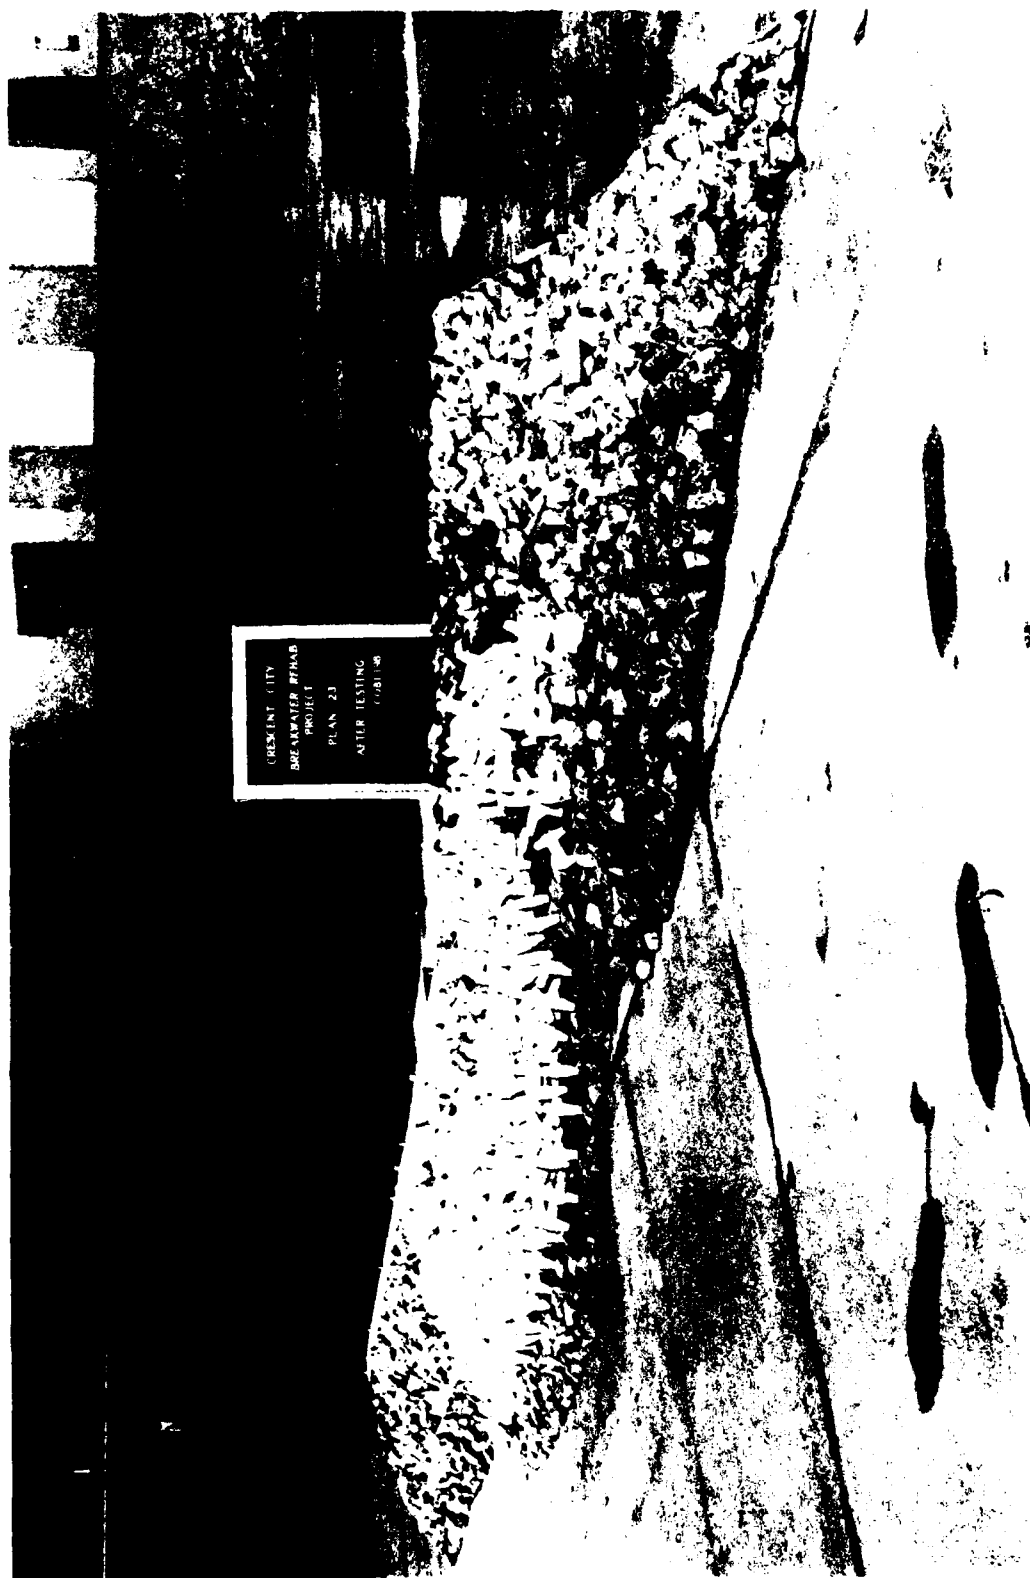
Photo 176. Seaward oblique view of Plan 23 after completion of abbreviated hydrograph

53. Plan 23 (Plate 25 and Photos 172-174) was similar to Plan 22, except coverage was reduced near the crown of the dogleg where dolosse were not needed and coverage was increased along the lower part of the seaward transition toe to provide additional protection in this area. A total of 484 42-ton rehabilitation dolosse were placed. Damage was severe in the seaward transition area for the abbreviated hydrograph. Photos 175-177 show the structure after testing.

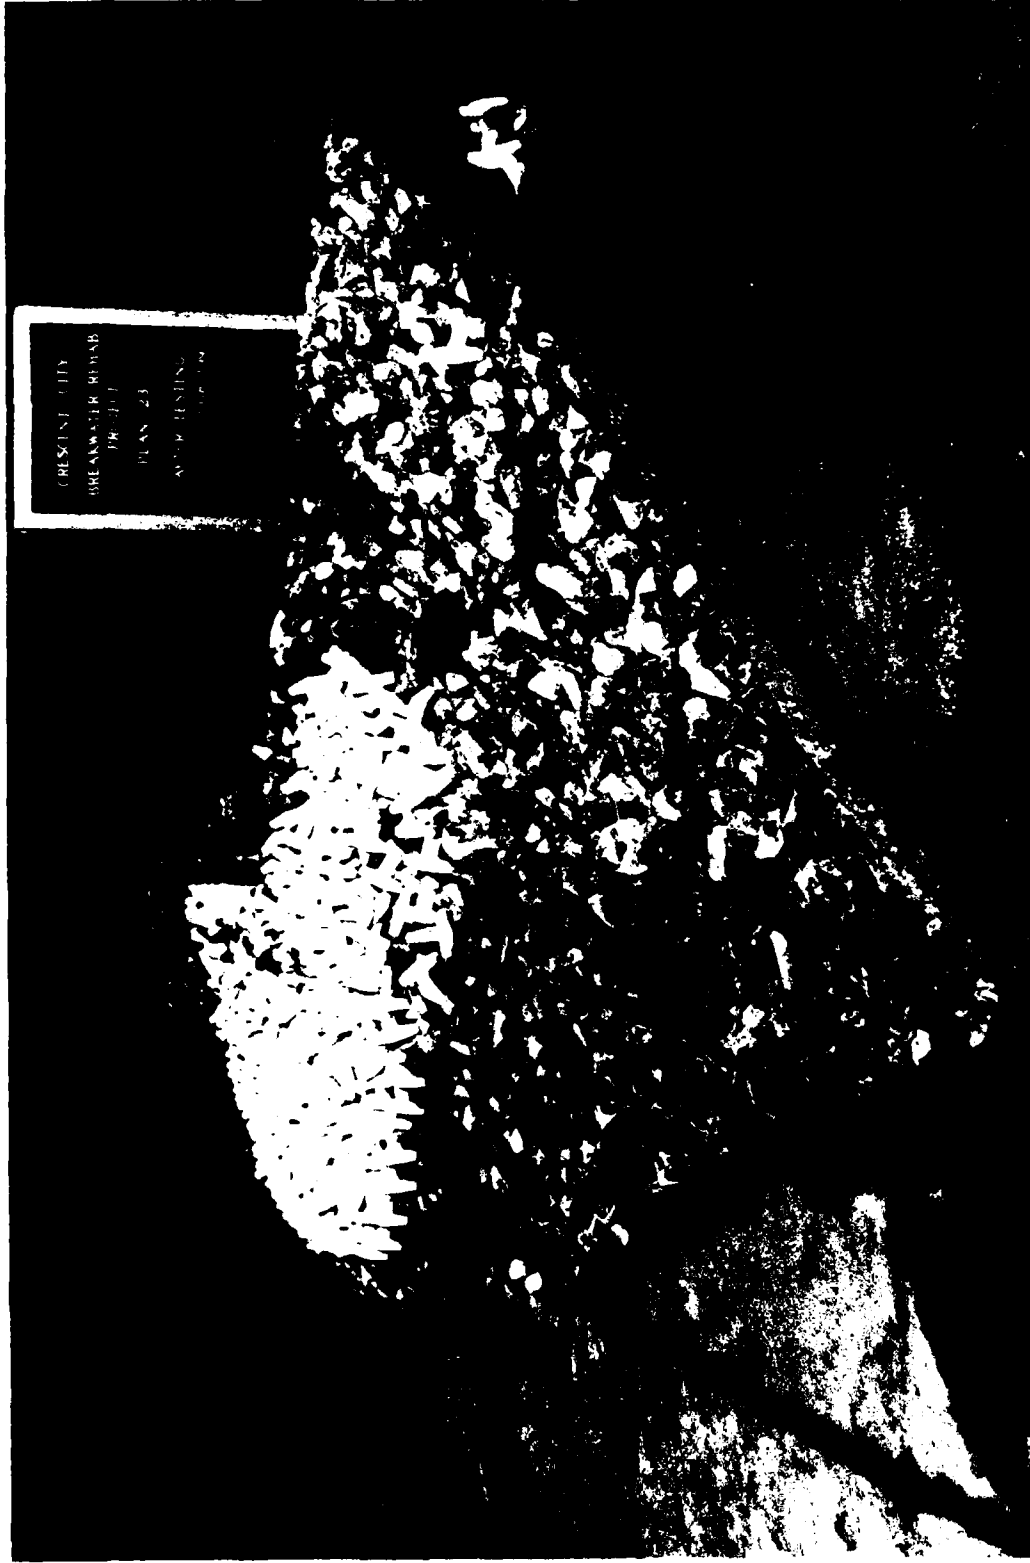
Photo 177. Seaward end view of Plan 23 after completion of abbreviated hydrograph

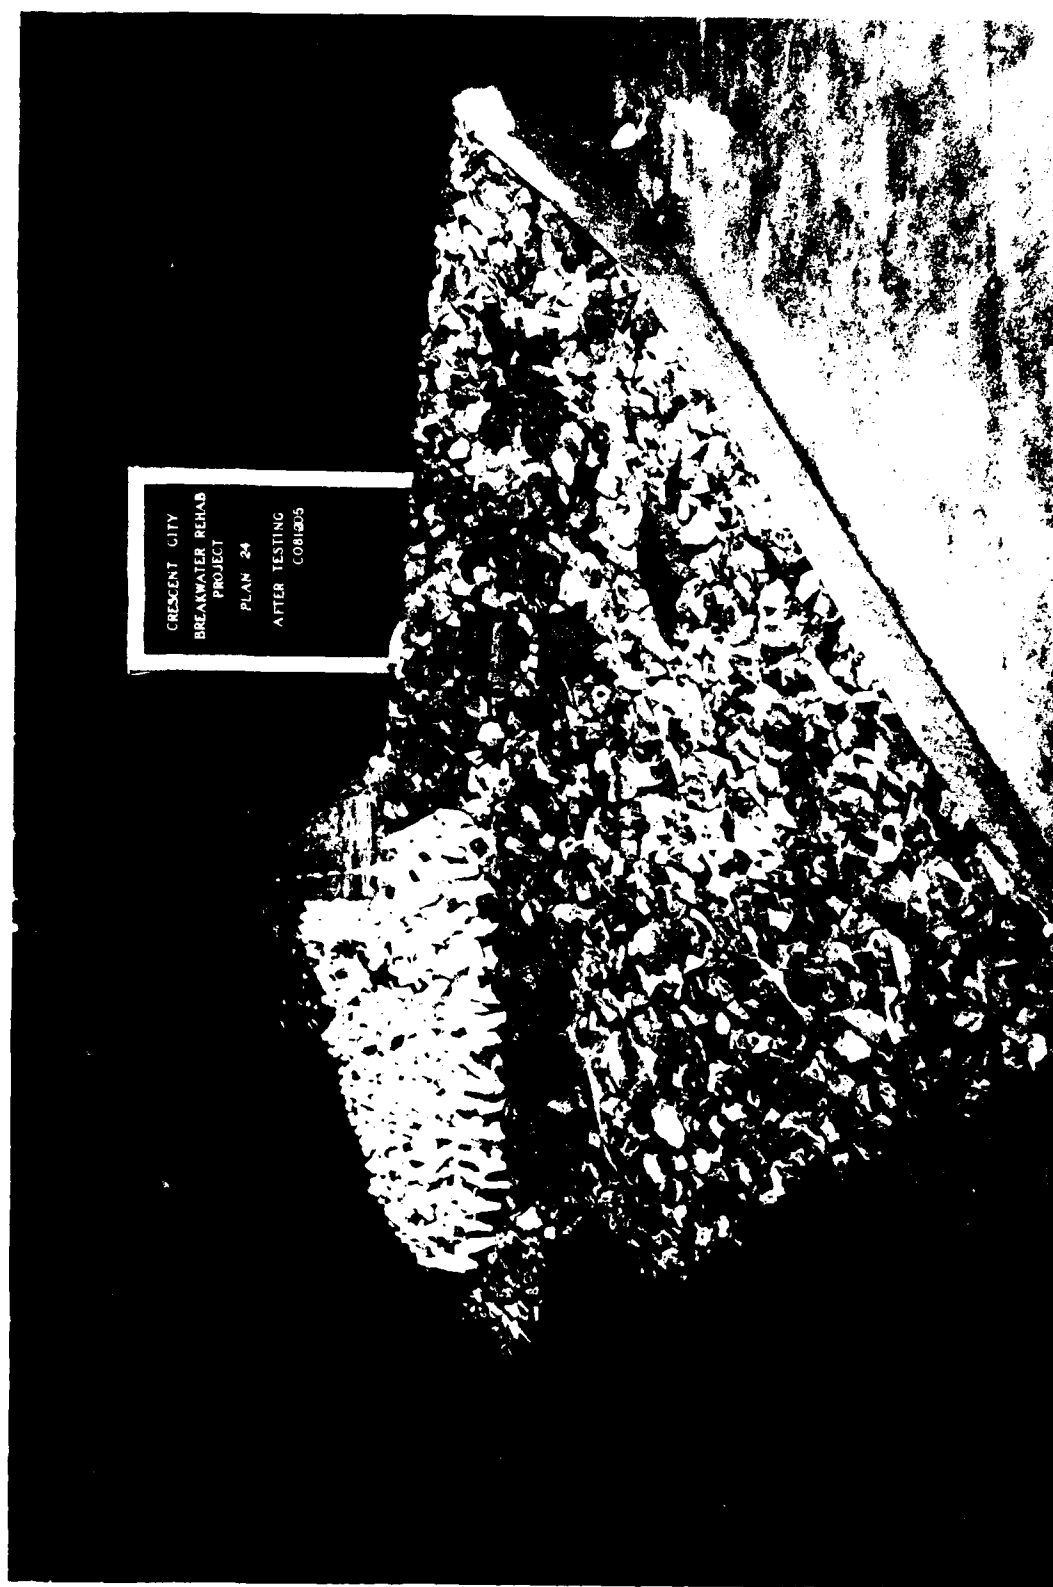
Photo 183. Seaward end view of Plan 24 after completion of abbreviated hydrograph

left without buttressing for subsequent storm events. Based on these results and discussion with the Los Angeles District, it was decided that the test should be continued using Hydrograph B (Table 3). During testing of Hydrograph B, deterioration of the 25-ton buttressing stone continued and additional separation and displacement of dolos occurred in the lower seaward quadrant. Photos 187-189 show the structure after cumulative testing of Hydrograph A and B. Based on the overall test results, it appears that the stability of Plan 24 is questionable.

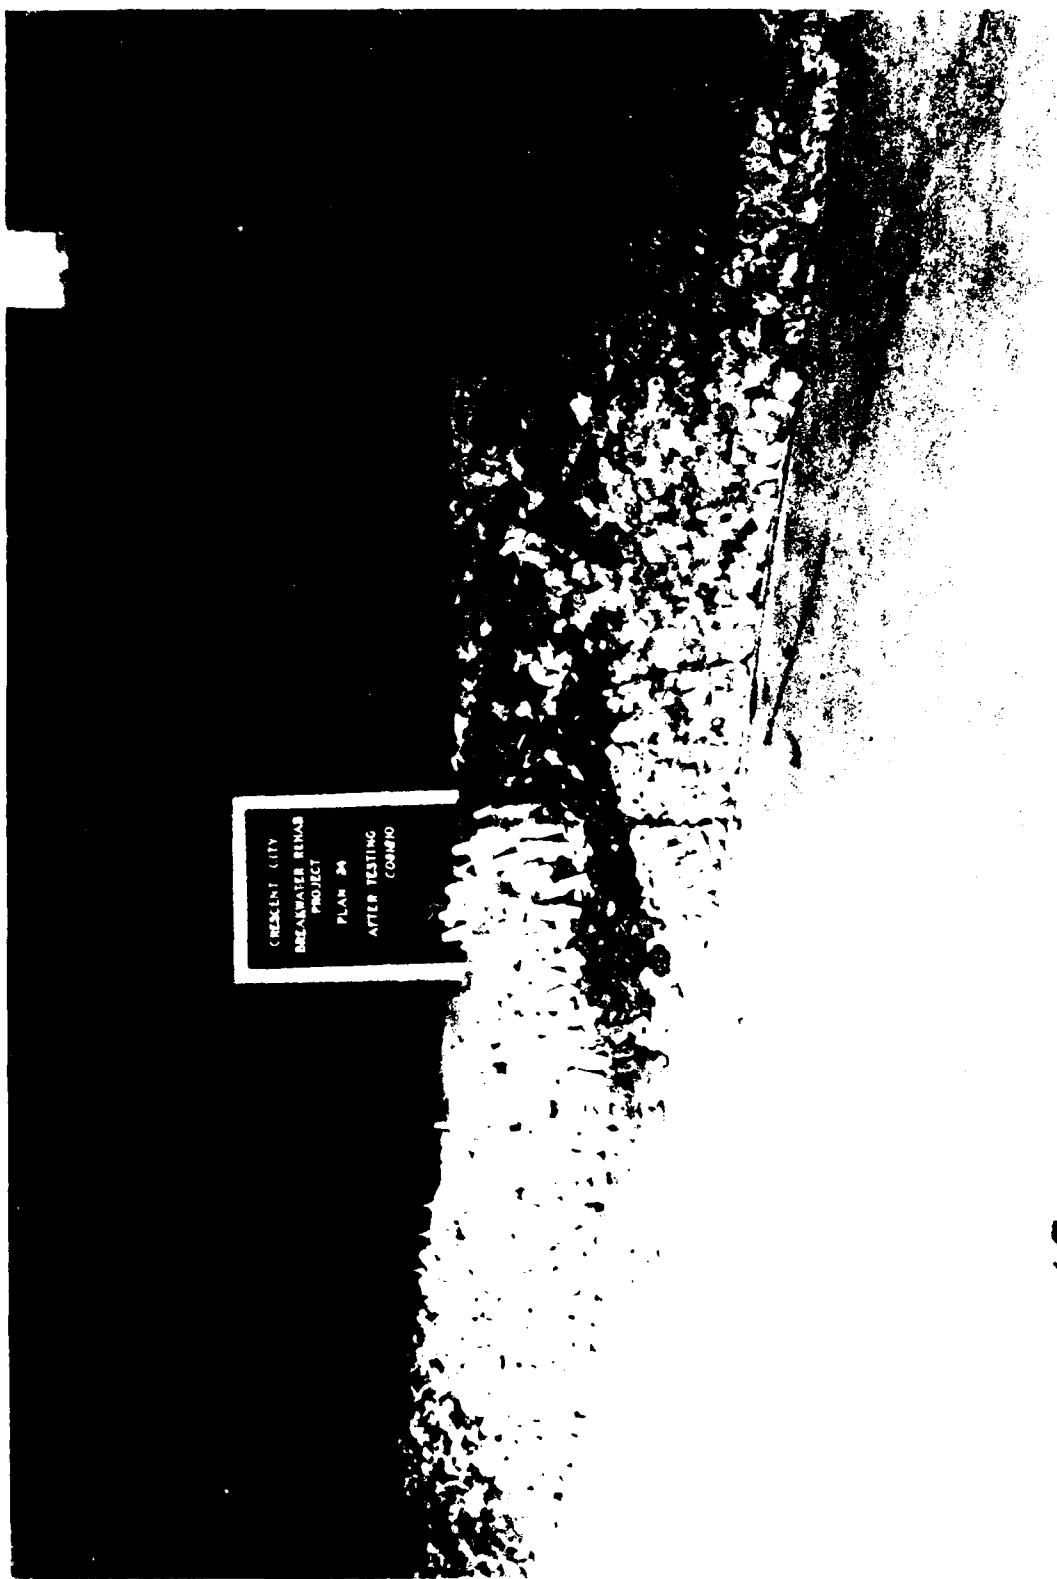
Photo 185. Seaward oblique view of Plan 24 after completion of Hydrograph A

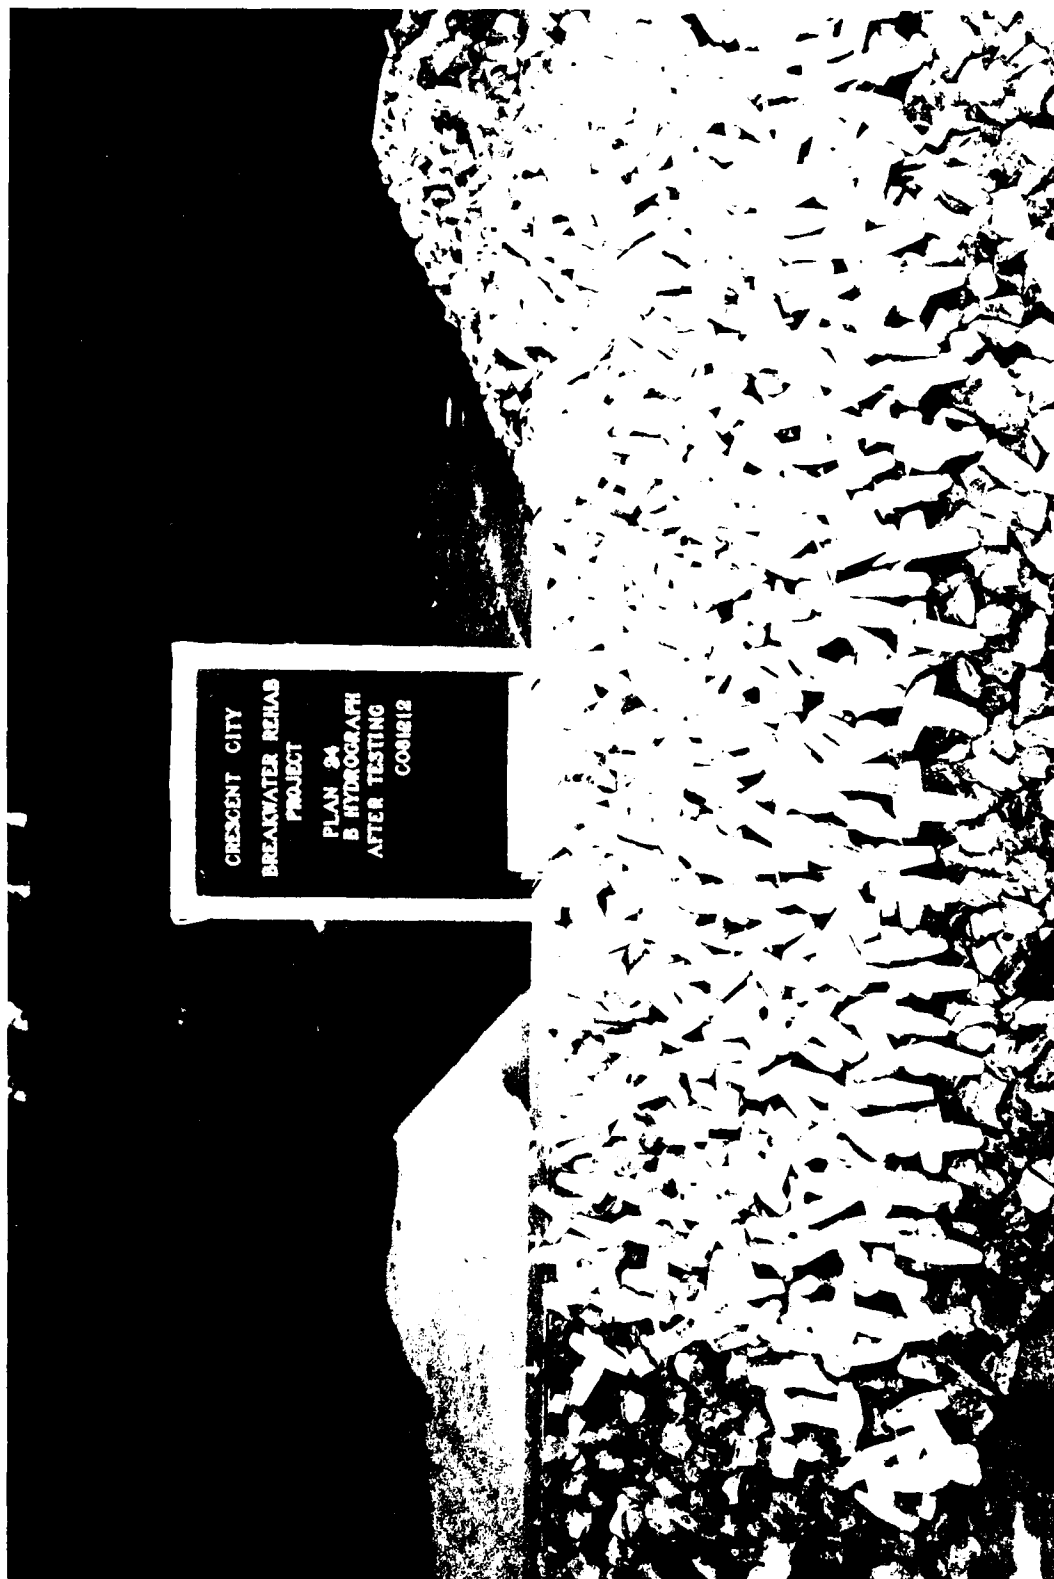
Photo 187. Sea-side view of Plan 24 after cumulative testing of Hydrographs A and B

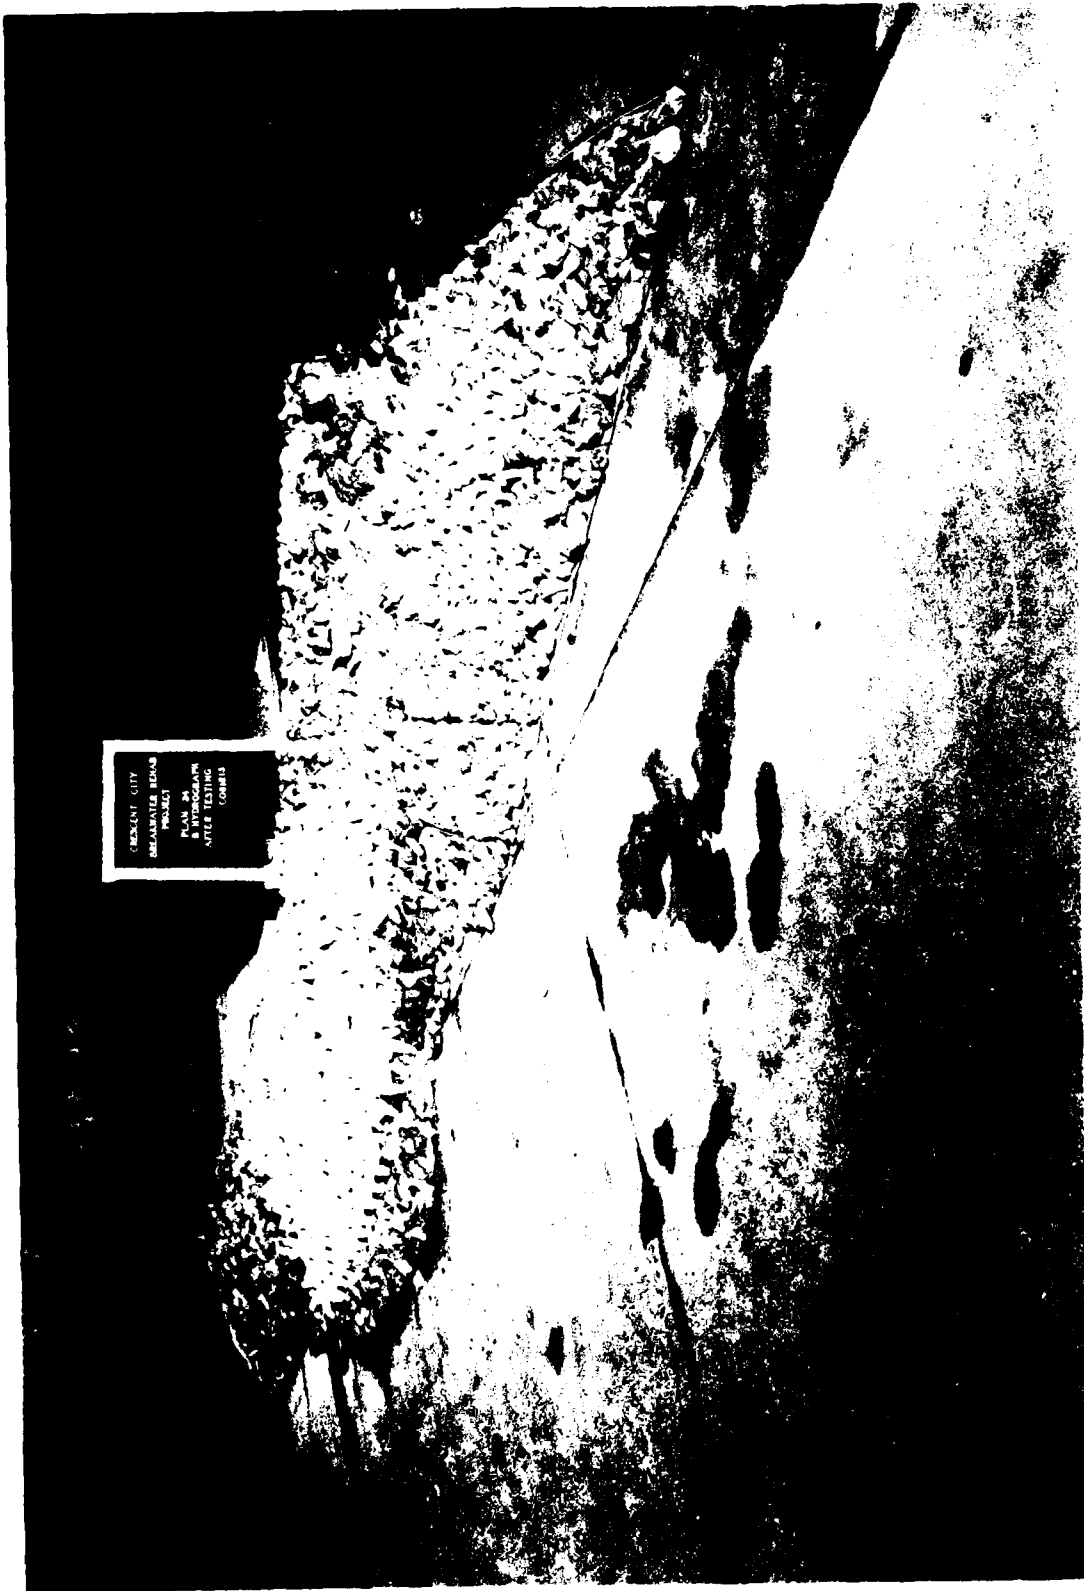
Photo 188. Seaward oblique view of Plan 24 after cumulative testing of Hydrographs A and B

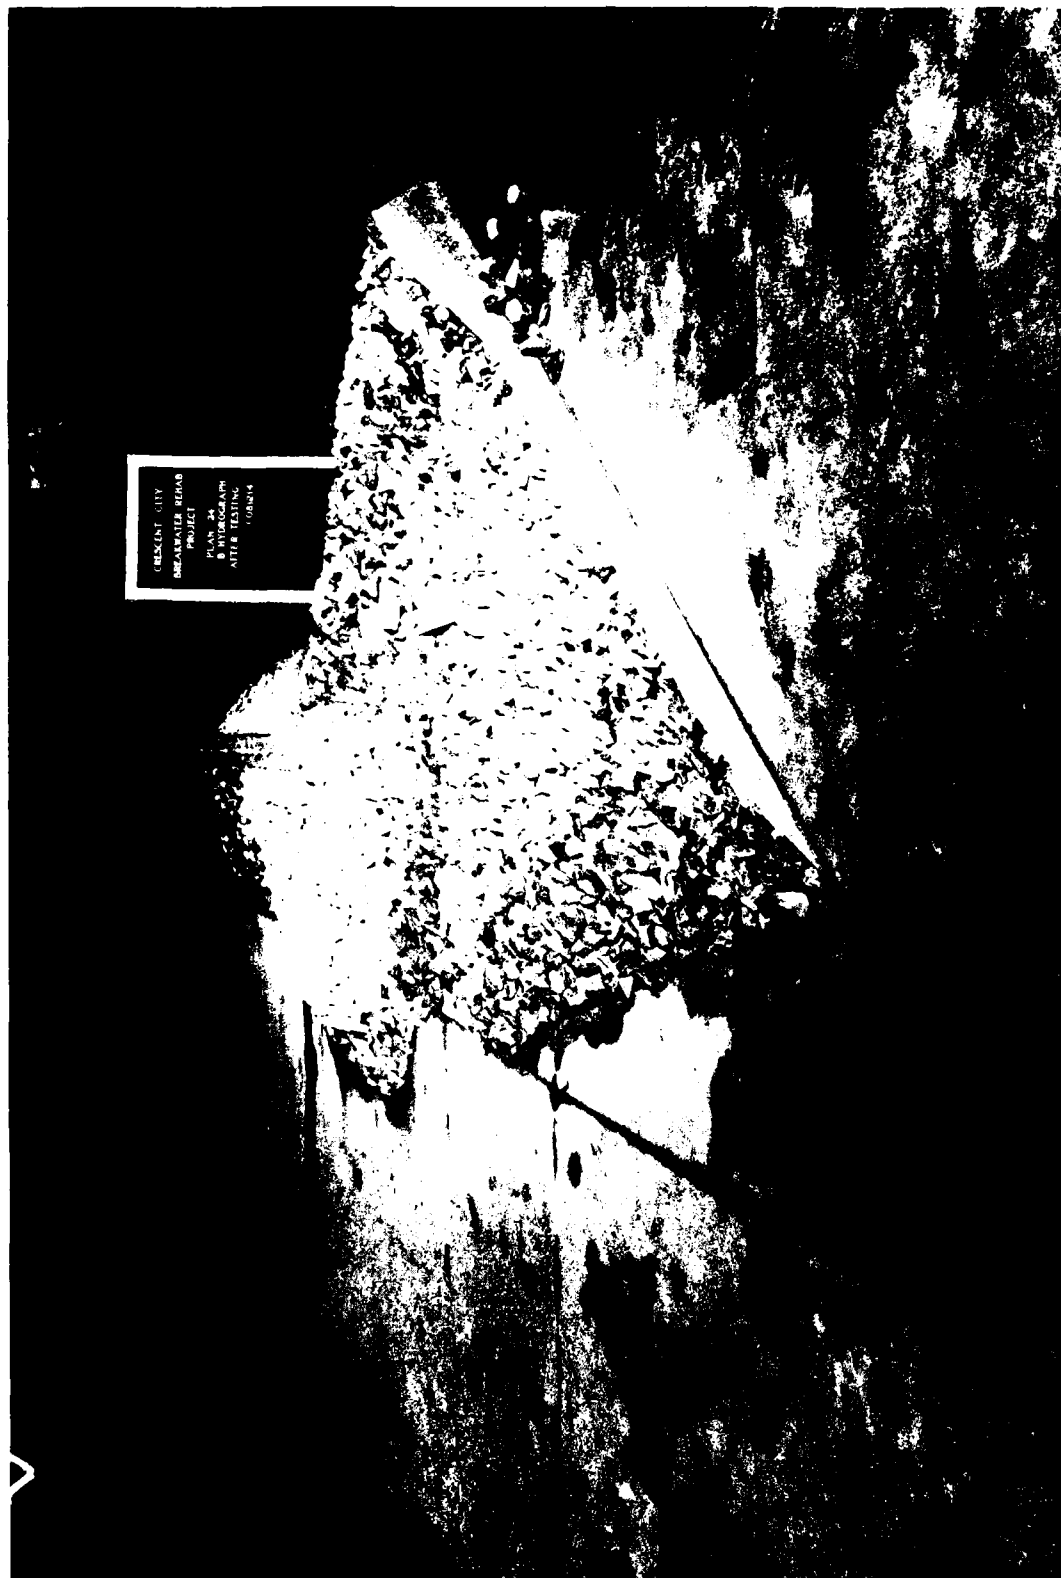
Photo 189. Seaward end view of Plan 24 after cumulative testing of Hydrographs A and B

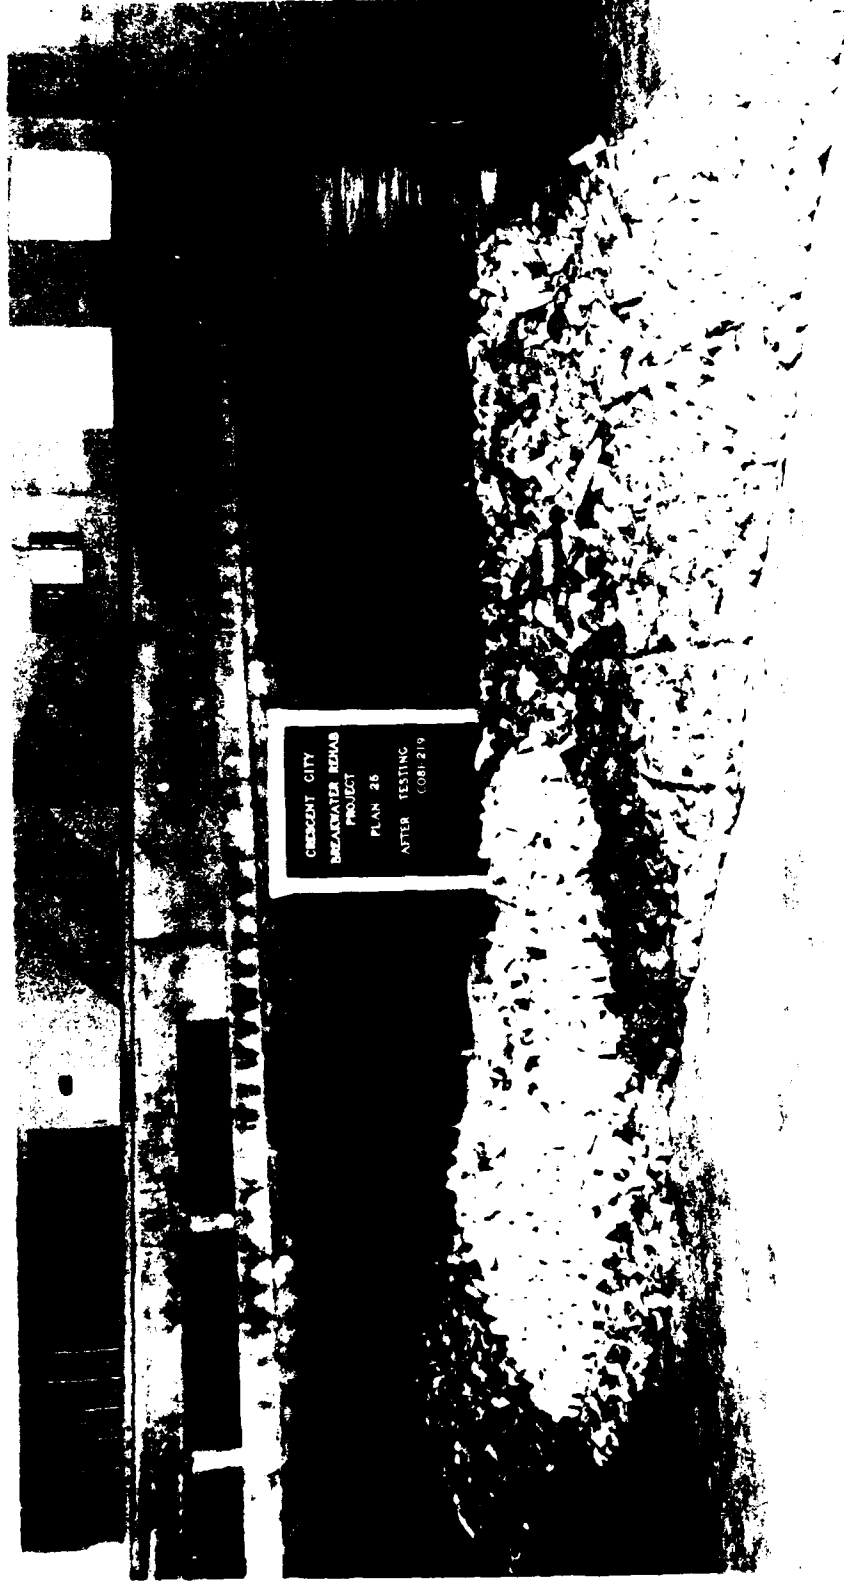
Photo 193. Sea-side view of Plan 25 after completion of abbreviated hydrograph

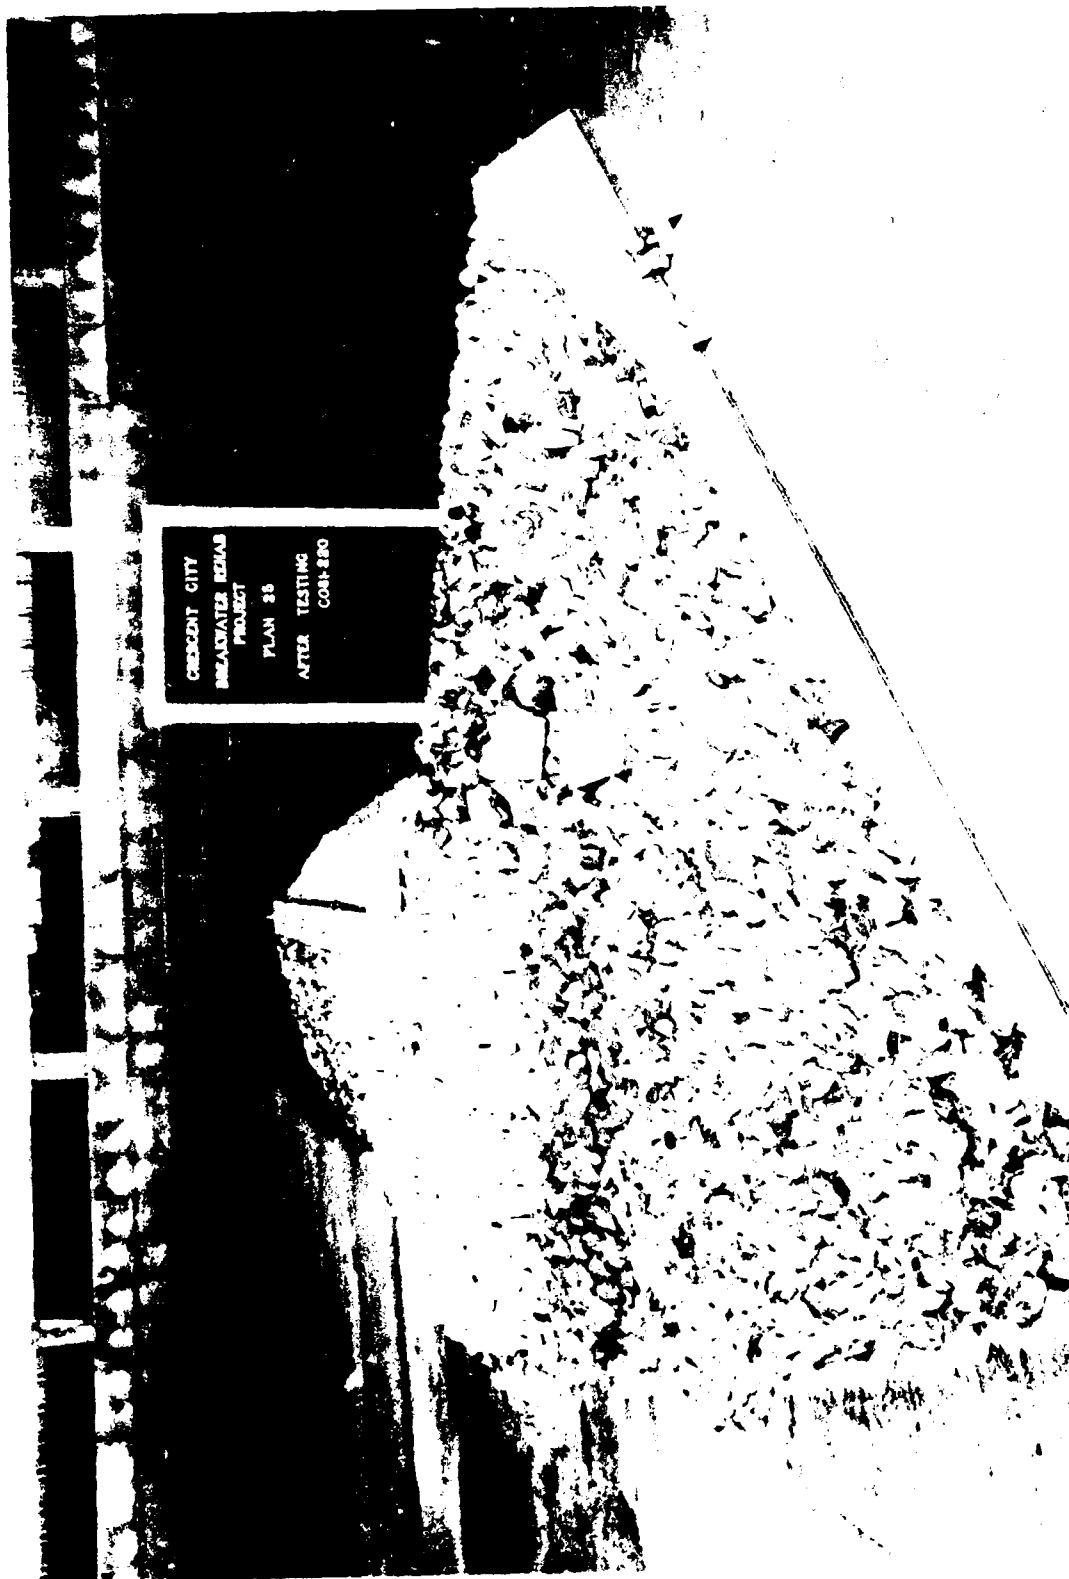
Photo 194. Seaward oblique view of Plan 25 after completion of abbreviated hydrograph

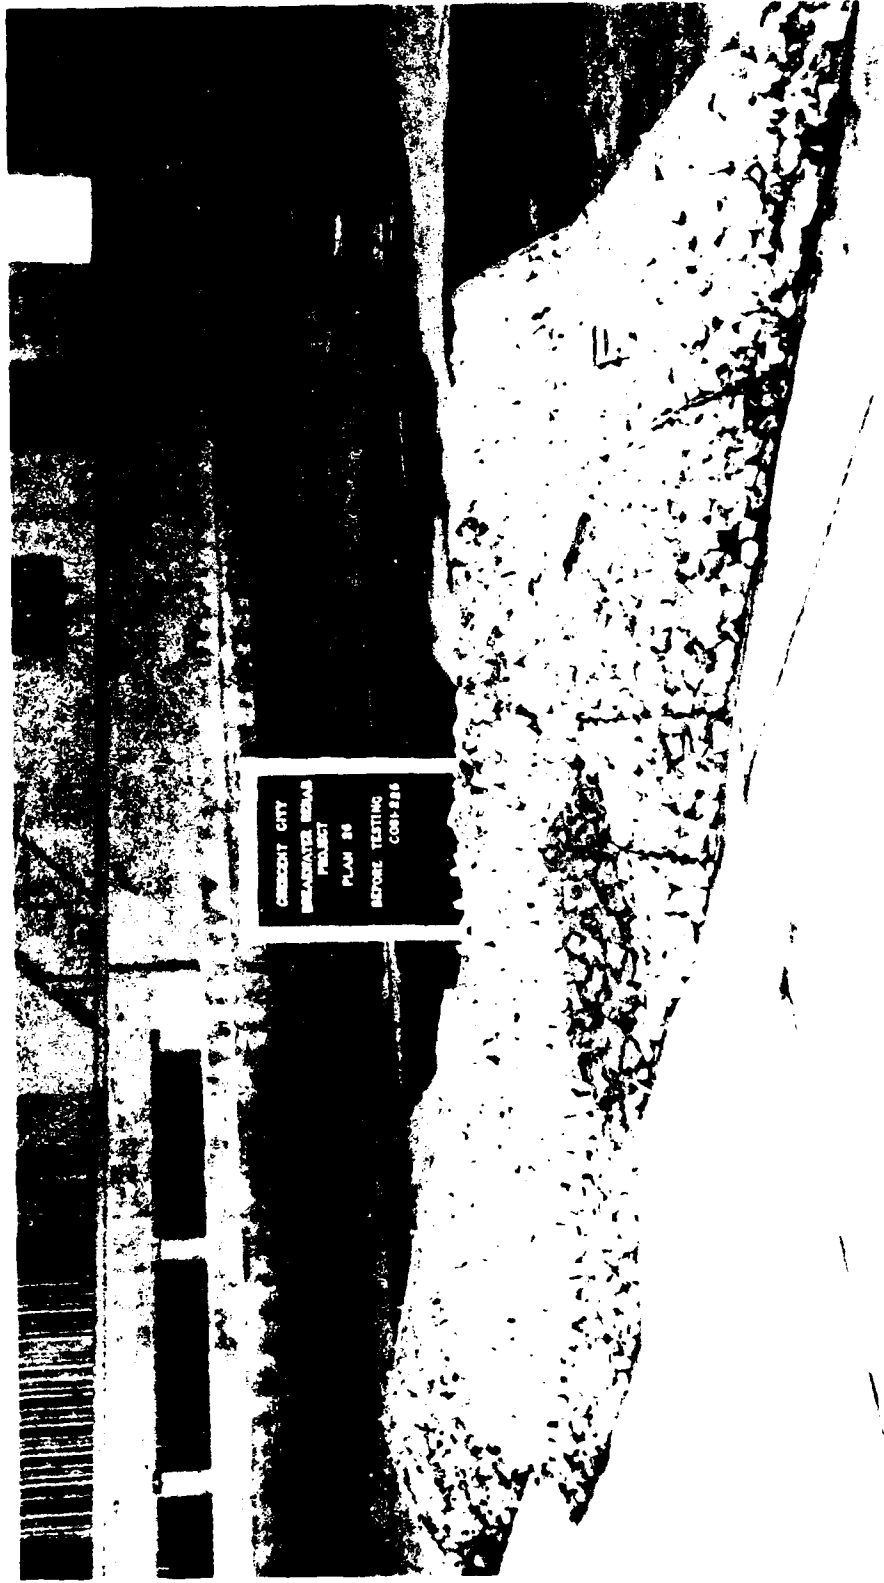
Photo 199. Sea-side view of Plan 26 before wave attack

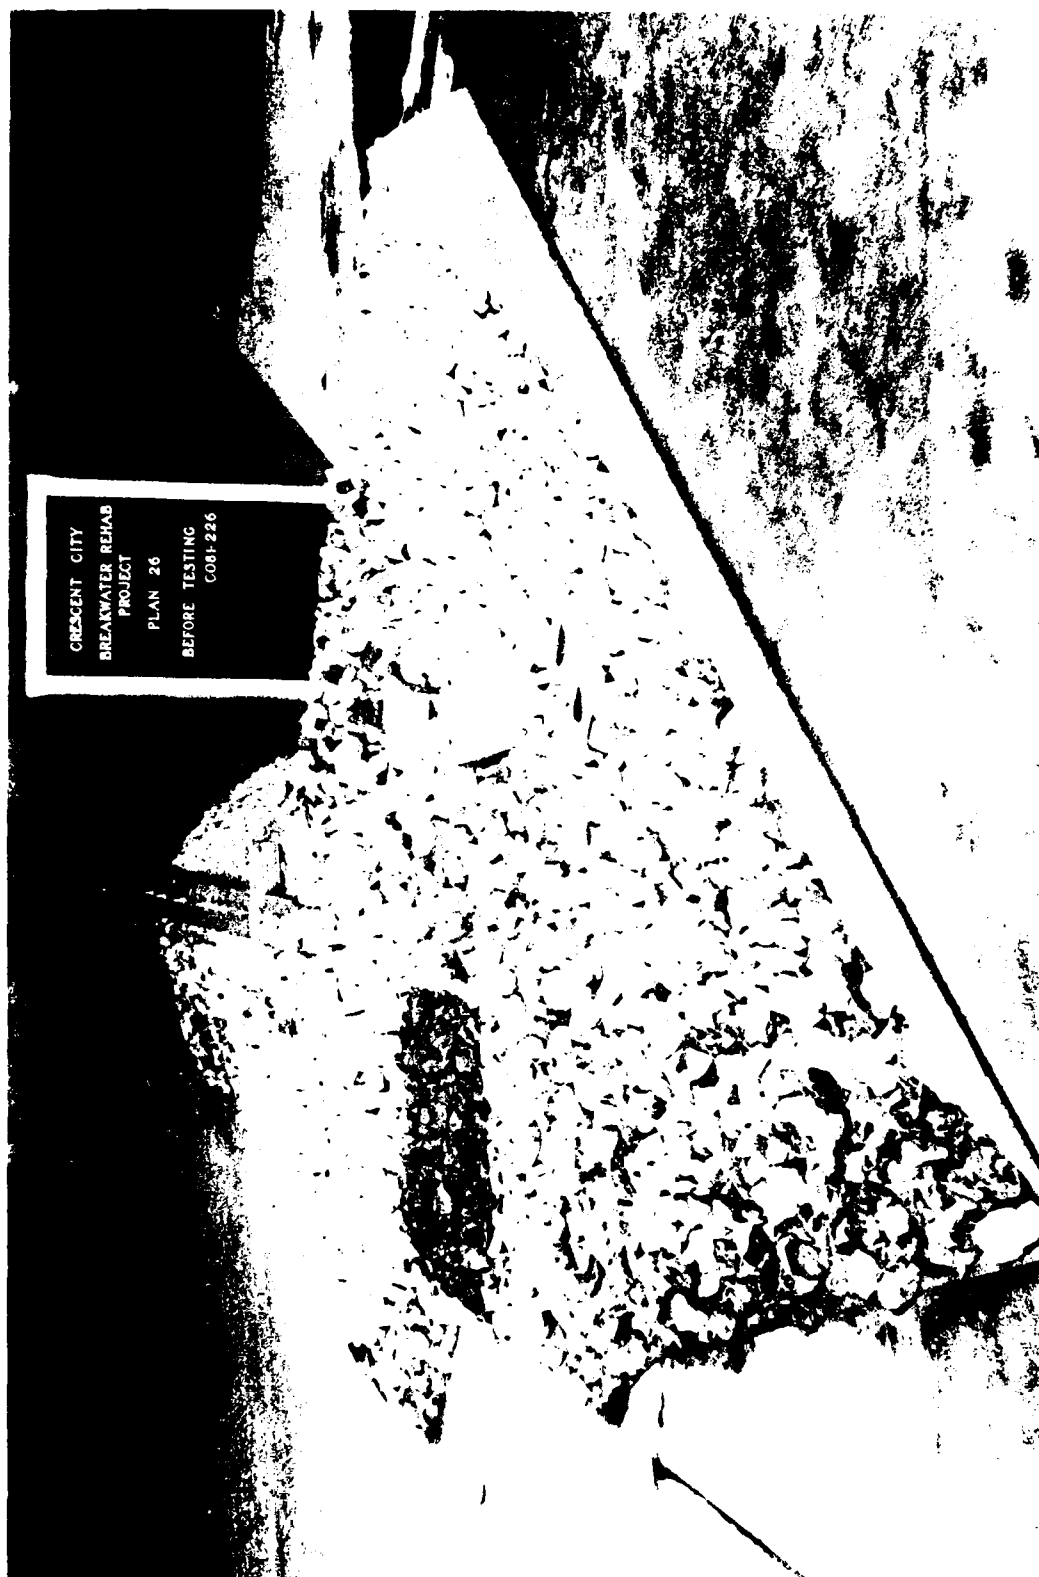
Photo 200. Seaward oblique view of Plan 26 before wave attack

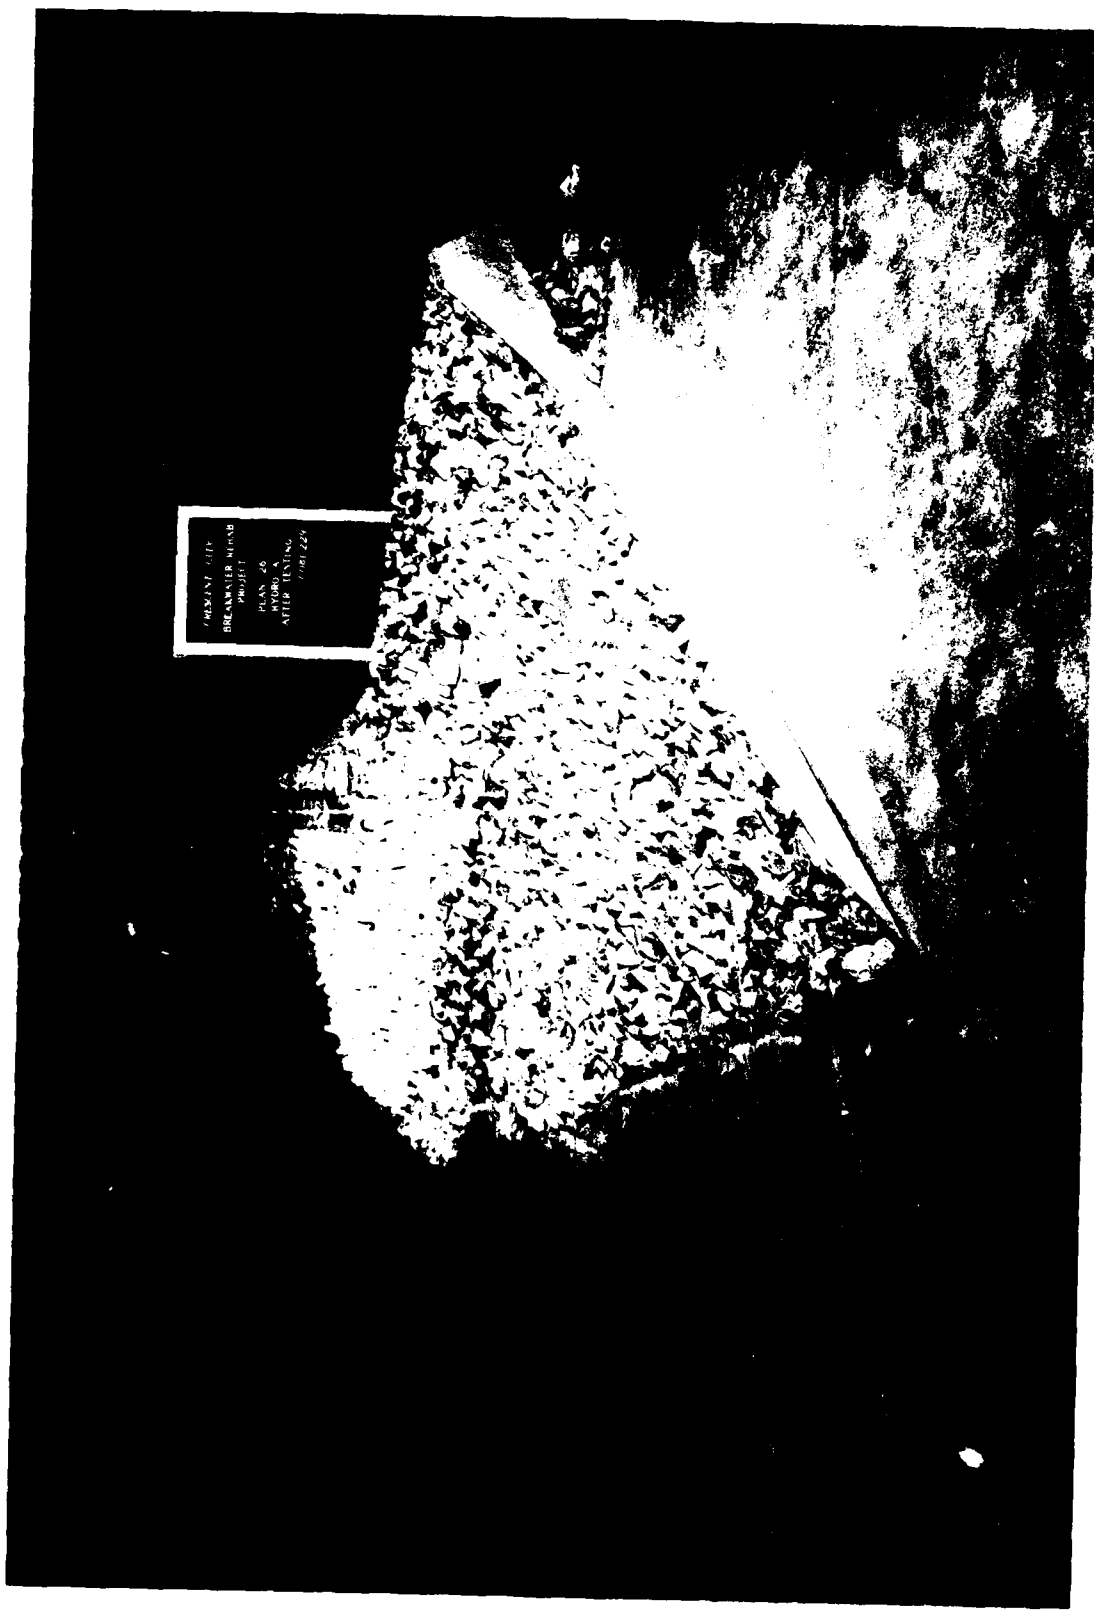
Photo 203. Seaward oblique view of Plan 26 after completion of Hydrograph A
